January 2017 FRONT SEAT NEWS

MODEL T FORD CLUB of NORTHWEST OHIO, INC.

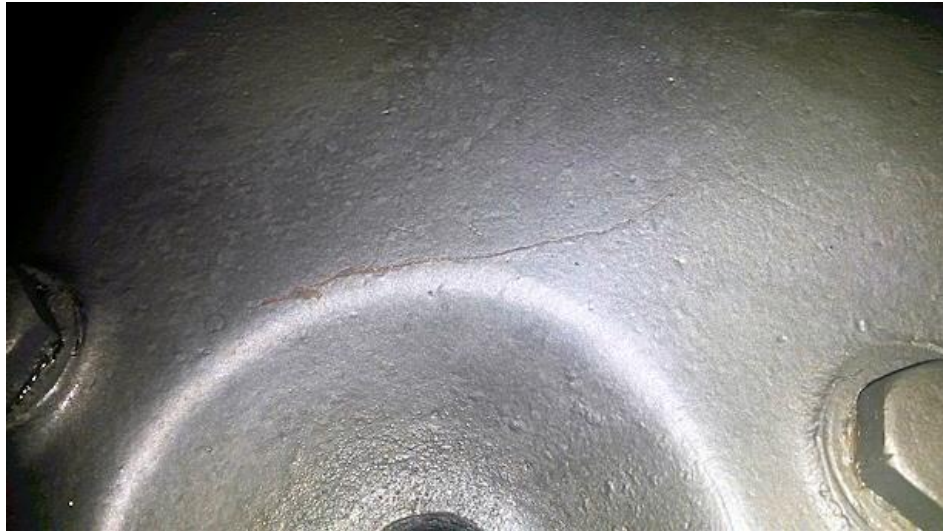
Jack fix a crack in the head of the same engine. Here are a few pictures of the process. The first picture is of the crack.

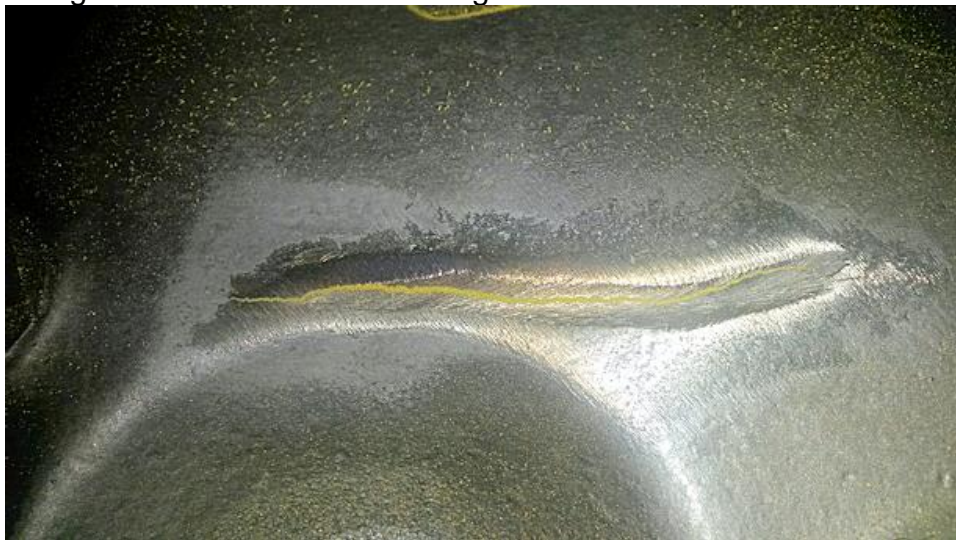
The second is the magna-flux crack. Note it is longer than the visible crack in the first picture.
